## Digital Documentation Techniques as Tools for Conservation of a Buddhist Stupa through Virtual Reconstruction

### INTRODUCTION ABOUT SANNATI STUPA

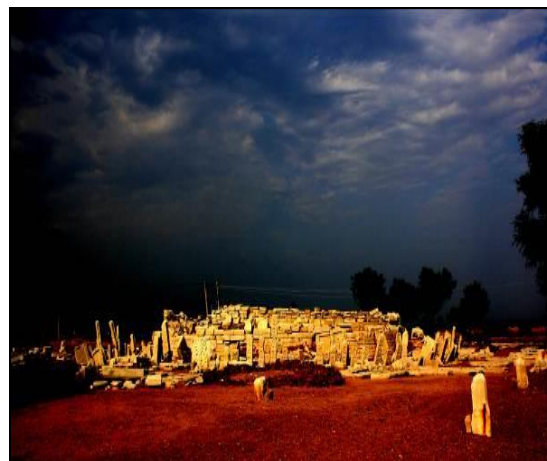
**Fig. 1:** Excavation Site of the Great Adholoka Maha Chaitya at Kanaganahalli.

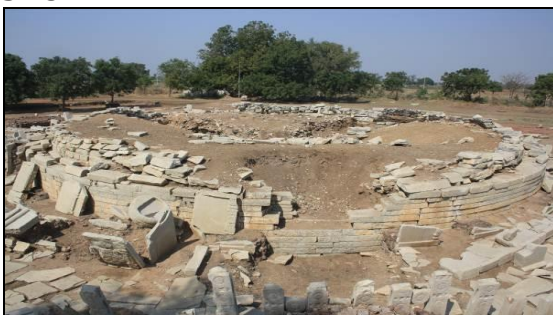
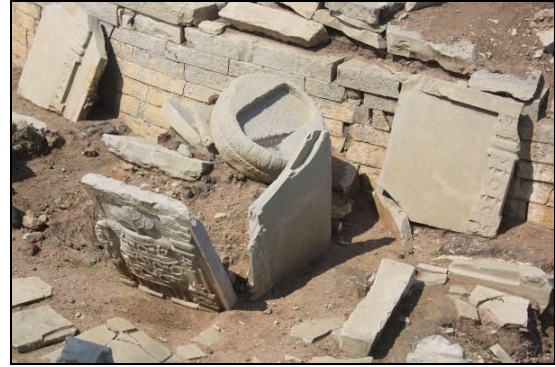
**Fig. 3(a, b):** Present Status of Stupa Site with Its Scattered Architectural Members.

The great stupa at Sannati has been covered under debris for nearly fourteen centuries and was found accidentally during an archaeological excavation. There was continuous agricultural practice on this mound for centuries before excavation. The possible cause of dilapidation according to the field archaeologists is due to a massive earthquake that happened sometime in 6<sup>th</sup> century AD (Figure 4(a, b)).

One can imagine the state of ruined condition of various parts of stupa from the photographs above and enormous challenges that it poses in documenting the stupa in “as – is” condition before any conservation efforts are made. After thorough investigations of the site conditions and initial assessment of the all the components of stupa, it has been decided to engage different methods of documentations have to be adapted for different applications. Following documentation techniques were adopted:

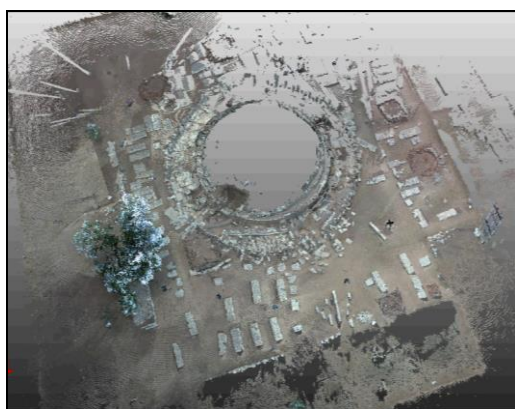
**Fig. 10:** *Image of Point-Cloud Data Obtained From Long-Range Laser Scanning.*

The entire site measuring approximately 90 m 100 m size to using a Faro long range (60 m range) scanner with 27 multiple station-points and finally integrated to obtain the point-cloud data to an accuracy of 2 mm (Figure 9).

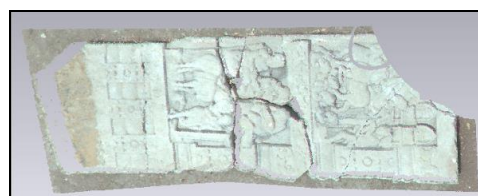
**Fig. 11:** *Sliced-up Point-Cloud Information for a Panel.*

This enormous point-cloud data generated has been used to prepare the overall master plan for numbering and sliced up to generate information to micro-level to ascertain the geometry, structural details and overall condition-assessment of the stupa (Figure 10, 11 and 12).

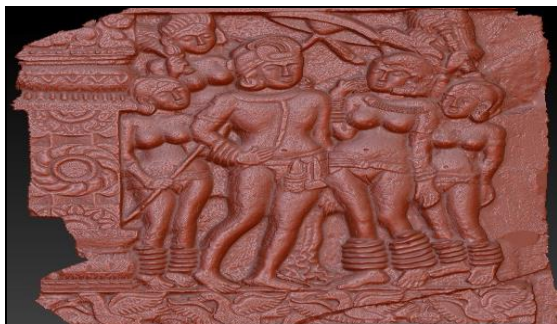
**Fig. 15:** Detailed Dense Mesh of Panel Depicting Emperor Asoka.

For further detailed studies of micro level information measuring 50 microns and below, a white light scanner was used. Due to enormity of the information generated, the objects were mapped using multiple scans and the data has been compiled to get very detailed information to achieve detailed dense meshes (Figure 114).

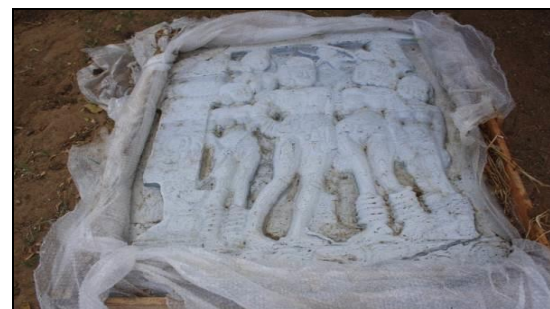
**Fig. 18:** Panel Replica Produced By Milling.

The data of short range white light scans is converted to machine program for obtaining various tool paths for different milling bits and using a seven-axis robotic arm milling machine (Figure 14, 15 and 16), the data has been used to replicate the precious sculptural details using limestone of similar composition to the original construction material used in the ancient stupa<sup>[1, 2]</sup>.
